# Back Lane Car Park Walk Round Risk Assessment

## 14 March 2019

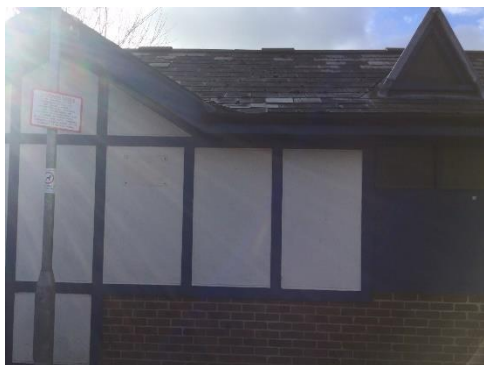
The tile off the toilet block roof has been repaired.

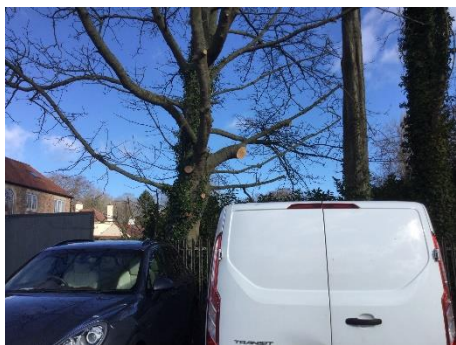
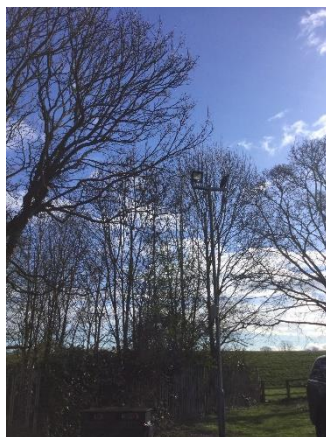
The branches overhanging from a neighbouring property have been cut back, including those which were obscuring the floodlights.

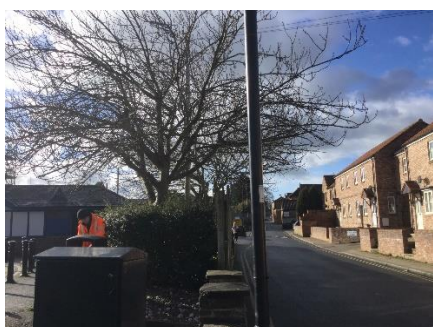
These trees may potentially obscure view of CCTV.

**RECOMMENDATION:** These trees to be inspected and any necessary work carried out.

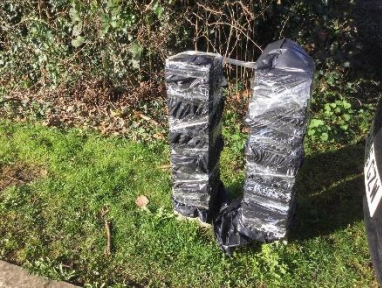
The water and electric points have been temporarily secured but repairs are necessary.
